WINWELL
FOUNDATION

Subsurface Acoustic Surveys of Swan and Canning River Shipwrecks

December 2025

**Prepared for Heritage Council of Western Australia
Heritage Grant Agreement 40CHG2025**

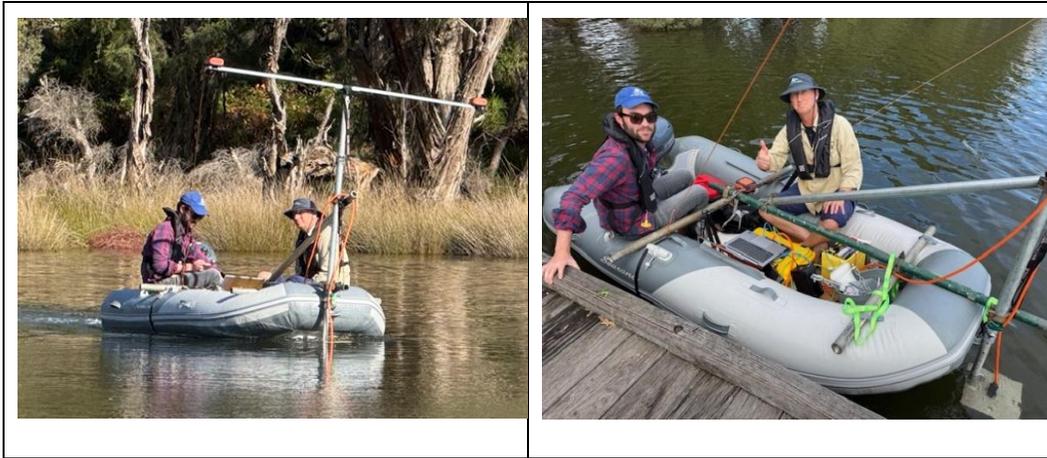
Figure 11. Ultra-shallow draft survey vessel on Bull Cr. with transducer and GNSS satellite receivers bow mounted.

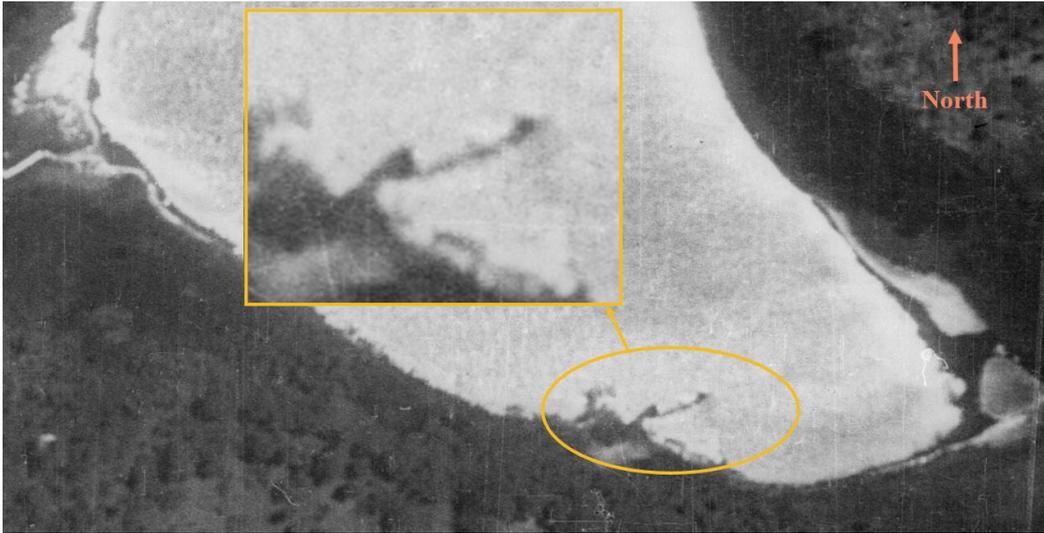
Figure 42. 1942 military aerial photograph of a barge at the head of Bull Creek (P. Morrison).

https://aerialphotography.ga.gov.au/Scanned/MAP/MAP1333/MAP1333_frame14117.tif One image extracted from this roll (Map 1333, Frame 14117) shows a double ended barge in the correct location and orientation (Figure 42). It clearly shows the forward deck and the cargo hatch with no indication of a centrally located boiler. The aft section is less clear, but there are no apparent structures nor timbers outside the line of the stern.
